Microseismic Railway Monitoring System Successfully Detects Rockfall Events

Working in partnership with Alstom Signaling, ESG installed a microseismic monitoring system along 250 feet of railway track, near the Dalles, Oregon. Analysis of data from a rockfall event enabled ESG to successfully calibrate the microseismic system so that real-time rockfall detection may be enabled, helping to reduce risk to oncoming trains.

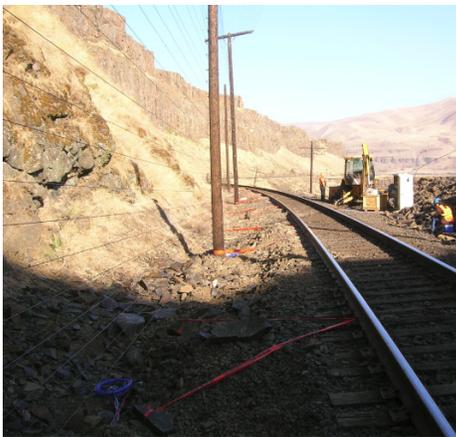
Fig. 1: Location of the seismic sensors (approximately in line with the hydro poles) in relation to the railway tracks and rock face

ESG installed a permanent microseismic railway monitoring system (MRMS) in September 2008 along a 250 foot length of railway track near the Dalles, Oregon that was prone to rockfall events. The system consists of 12 uniaxial sensors installed at a distance of 3-6 feet from the edge of the railway track (Fig. 1) and continues to operate in full capacity. The sensor cables connect to a small sensor splice box and a trunk cable running parallel to the tracks (Fig. 2). Microseismic data is digitized by two Paladin™ data acquisition units, operating at a sampling rate of 5000Hz and 24-bit resolution.

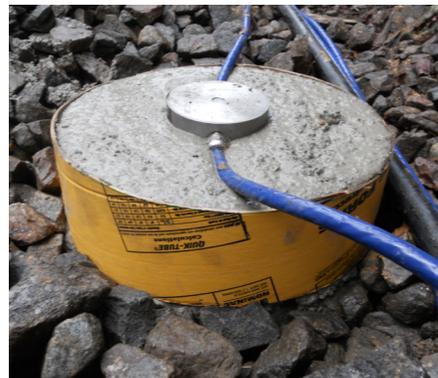
Fig. 2: Standard MRMS sensor installed near a railway track

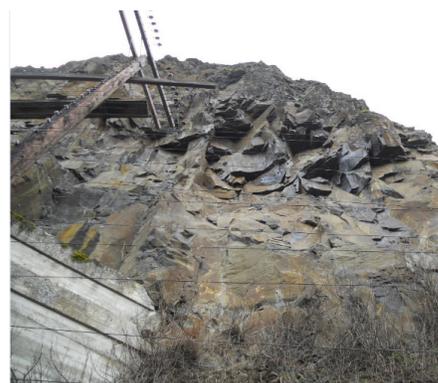
Fig. 3: Cliff face located above the train tracks where the rockfall originated

A known rockfall event occurred on December 17, 2010. The main rock involved in the rockfall appears to have fallen from a cliff face at a height of about 50 ft (Fig 3). A segment of the continuous microseismic data collected at the site consisting of a period of 7 days and including the rockfall event yielded a total of 1915 event triggers (Fig 4a). Closer examination of the source characteristics of the rockfall event enabled ESG to fine tune the triggering methods to isolate the rockfall event from all other events so that the system may be used in real time to warn oncoming trains of potential hazards.

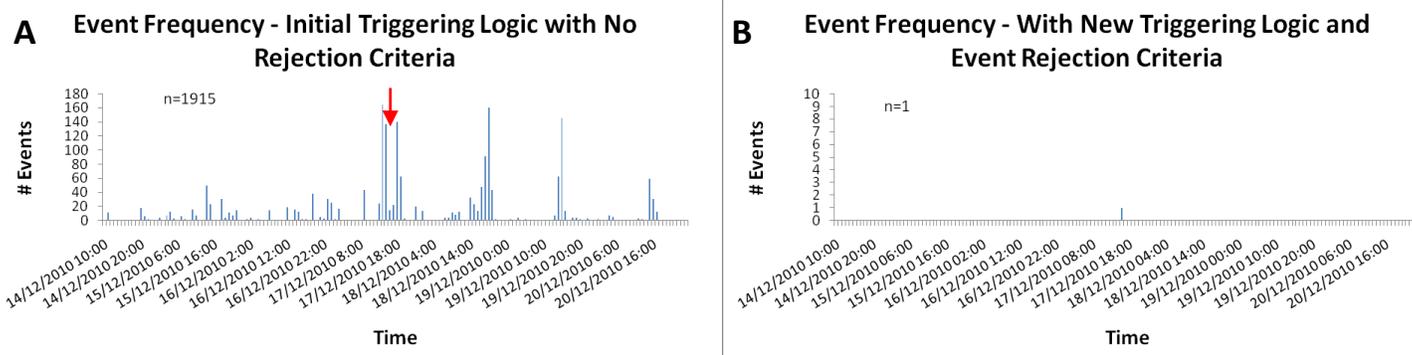
Fig. 4: Event-time histograms with 1-hour windows using A) initial triggering parameters and B) new triggering logic and event rejection criteria. The time of the rockfall is marked with an arrow in A

Upon closer inspection of the data, it was determined that the microseismic event triggers could be separated into five event types (passing train, car on tracks, electrical noise, small seismic event, rockfall event) based on the specific seismic characteristics of each event type. By optimizing the triggering logic and implementing an event rejection function, ESG was able to filter all event triggers with the exception of the single rockfall event (Fig 4B).
